March 7, 2006

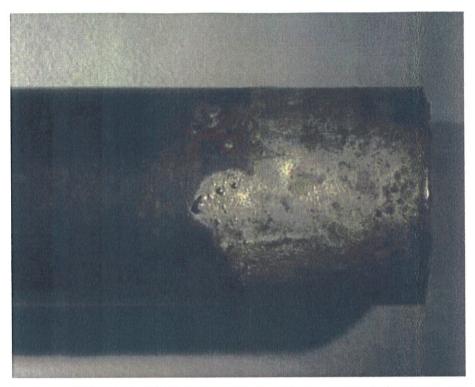
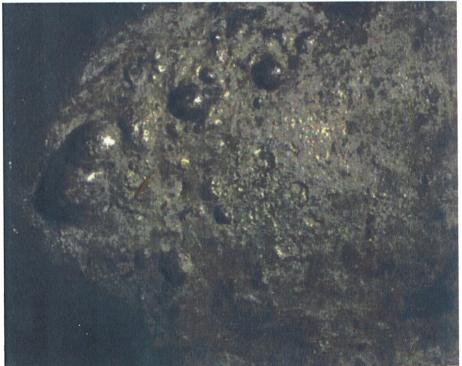
Joint Section 3 refers to the copper tube that was soldered to the female brass compression fitting. Stereomicroscope photos of Joint Section 3 are shown in Figure 24 and Figure 25. The prominent features on Joint Section 3 are the large deposits of solder residue on the outer surface of the tube. Unlike Joint Section 1, the solder on the surface of this section of the copper tube appears to have been molten at some point after the joint was separated. This section of tubing was also cross-sectioned and metallographically prepared to analyze the interface between the copper tubing and the solder. An optical photomicrograph of this interface is shown in Figure 26. The thickness of the solder deposit on the copper tube is $\sim 200 \ \mu m$, which is consistent with the thickness of the solder left on Joint Section 1.

Figure 24. Stereomicroscope images of Joint Section 3 showing the solder remaining on the outer surface of the copper tube.

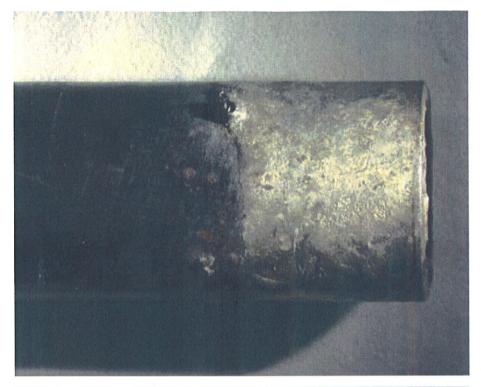
Figure 25. Stereomicroscope images of Joint Section 3 showing the solder remaining on the outer surface of the copper tube.

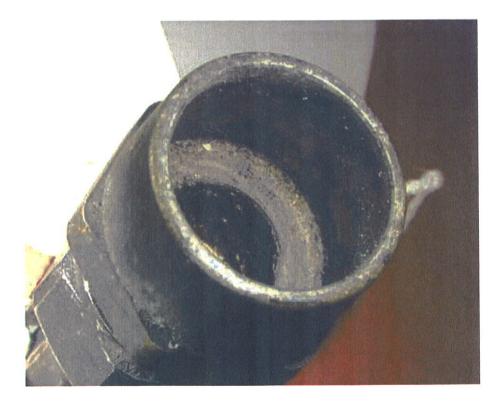
Joint Section 4 refers to the female brass compression fitting that was soldered to the copper tube Joint Section 3. A stereomicroscope image of Joint Section 4 is shown in Figure 27. A backscattered SEM image of the inner surface of this fitting is shown in Figure 28. EDS analysis was performed in the regions outlined by red boxes #1 and #2. The spectra acquired from this analysis are shown in Figure 29 and Figure 30. As with the other brass fitting, the presence of tin on the surface is indicative of a surface film of solder, whereas the copper and lead are from the brass fitting. Figure 31 contains optical photomicrographs showing the polished cross-section of Joint Section 4. The thickness of the solder residue on the inner surface of the brass fitting is much less than that found on the copper fitting. This finding is similar to that for other brass fitting: Joint Section 2.

Stereomicroscope image of Joint Section 4. Figure 27.
